February 7, 2007

Re: Water Leak Test of 6<sup>th</sup> Floor Slender-Wall Panel (Panel #SWP 15/28)  
Virginia Beach Town Center – Westin Hotel Tower  
Virginia Beach, Virginia  
CTI Project No.: 00G-100

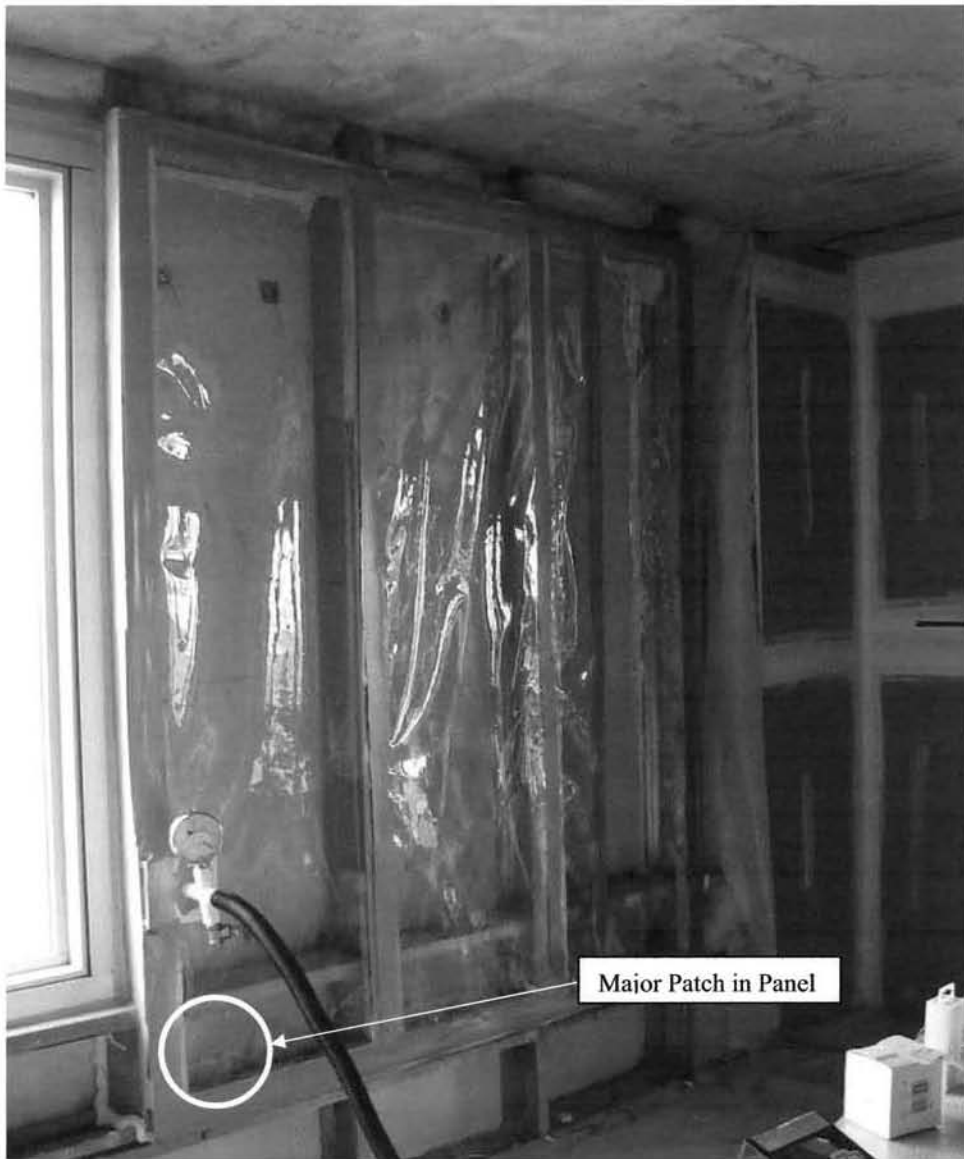
Photo #1  
Vacuum Chamber

accompanying panels. This panel required some patching and repair due to unspecified manufacturing / handling / installation difficulties, and the performance of the repaired area was to be evaluated through this current testing process. The tested area measured 84 inches wide by 72 inches high and encompassed the referenced major patched area in the bottom left corner of the test chamber, when looking at the panel from the inside of the room. Please see photo #1.

A vacuum chamber was attached to the interior side of the panel. The vacuum chamber was constructed and sealed to the panel and building frame and a clear vinyl sheeting was applied to complete the test chamber. Please see Photo #1. CTI provided all instrumentation and testing equipment to conduct and monitor the test.

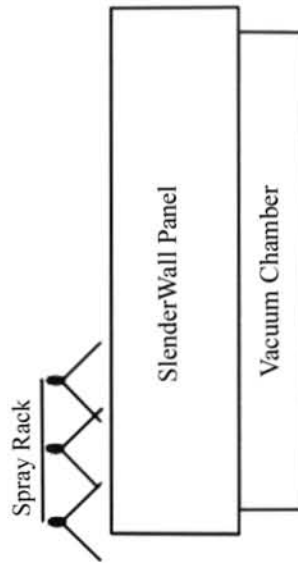
CTI's spray rack was attached to a swing stage on the exterior of the building wall. The spray rack was stationed to maintain a stand-off of twelve inches from the wall panel. The water spray consistently wetted an area of 48 inches by 140 inches at a rate of 4.67 gallons per minute per square foot at a pressure of 15 PSI delivery to the spray rack. The rack was positioned with its long axis in the horizontal plane. Please see Sketch #1. Employing this manner of positioning, the rack was moved vertically into three positions. The purpose of the three positions was to cover at least one-third of the test area of the panel at each position. The duration of the testing was fifteen minutes at each position. It is important to note that the lower one-third of the panel was exposed to residual cascading water flow from the above rack positions, resulting in 45 minutes of testing exposure. The middle third was subjected to 30 minutes of testing exposure.

Spray Rack Positioned at Bottom Third of the Panel Test Area

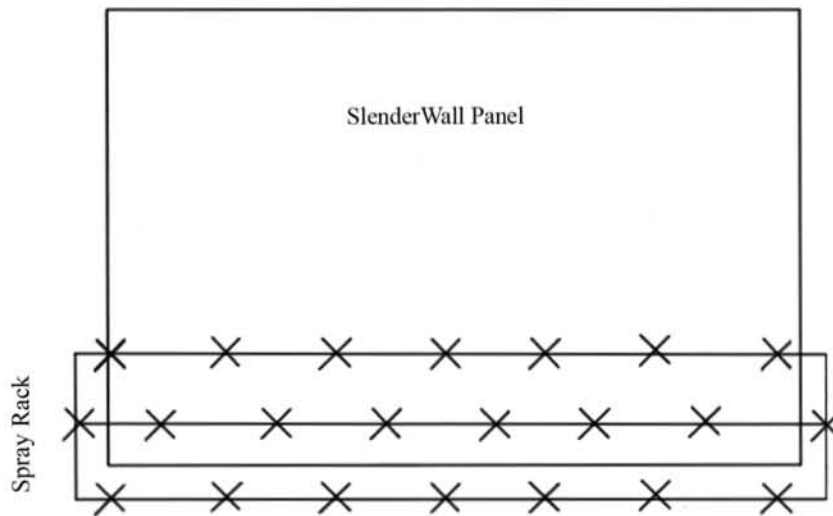
Sketch #1

Spray Rack Positioned at Bottom Third of the Panel Test Area
